Confidential Inspection Report

Prepared by: Bent Nail Inspections
3313 W Cherry Ln. PMB#509
Meridian, Idaho 83642
208-869-5557 dstrand35@cablone.net

February 1, 2009

Inspection Date:
October 12, 2008 10:00 AM.
Client:
Joe Smith.
Inspection Site:
1234 Rose Dr.
Anywhere, ID
House Occupied?
No.
People Present:
Listing agent, Purchaser.

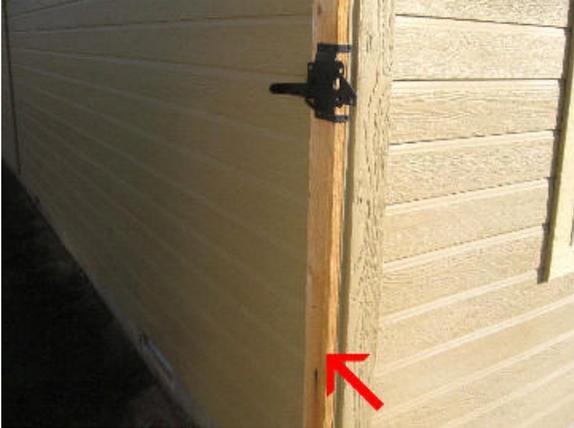
Gates and Latches:

Trim that gate latch is mounted on is not finish painted.
Satisfactory - The gates and latches are performing as intended.

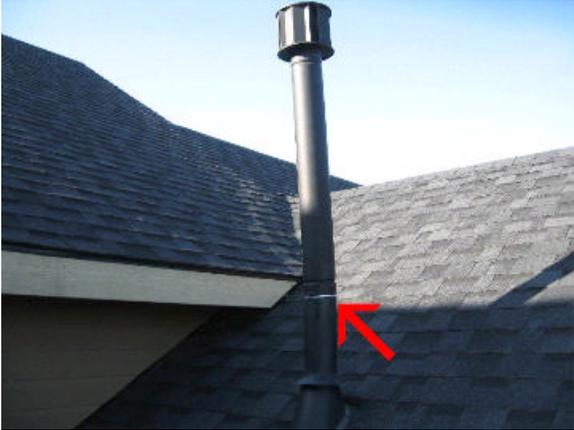
Gas Services:
Vents Noted From Roof View:
Stack is loose and not secured at joint.

There is at least one gas-fired vent stack through the roofline. The stacks appear to be installed two feet higher than the adjacent roof line.
Stack is loose and not secured at joint.

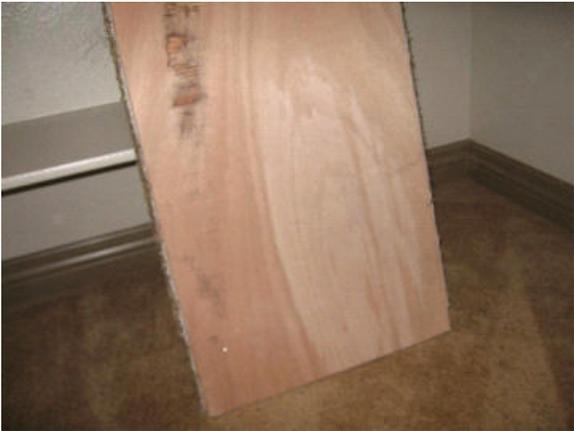
Location of Crawlspace Entrance:

There is an interior entry to the crawlspace. Hall closet and master bedroom closet.
Crawl space entrances are without the benefit of insulation.

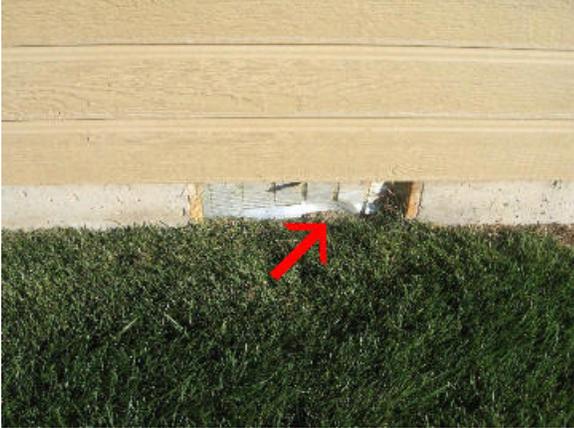
Crawlspace Ventilation:

Satisfactory - The cross-ventilation in the crawlspace appears to be adequate.
Crawl space vent in the SW corner of home has grass growing up to it and it is pushed in. Well guard should be installed to protect vent.

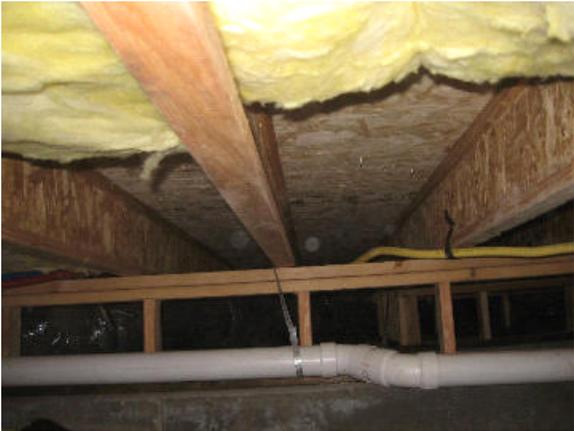
INSULATION

Insulation is missing under den and part of living room area.

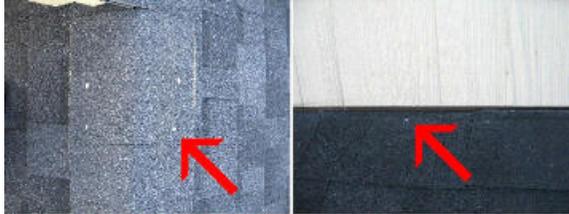
Condition of Roof Covering Material:

Satisfactory - The roof covering material is in a condition that is consistent with its age and method of installation, showing no deficiency or cause for immediate concern.

Caulk nails on roof to prevent water intrusion.

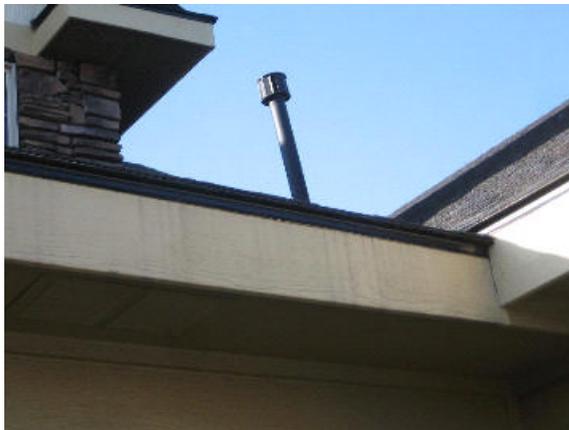
Roof Gutter System:

No gutters are installed on home. Recommend installing gutters to prevent water damage and move water away from foundation.

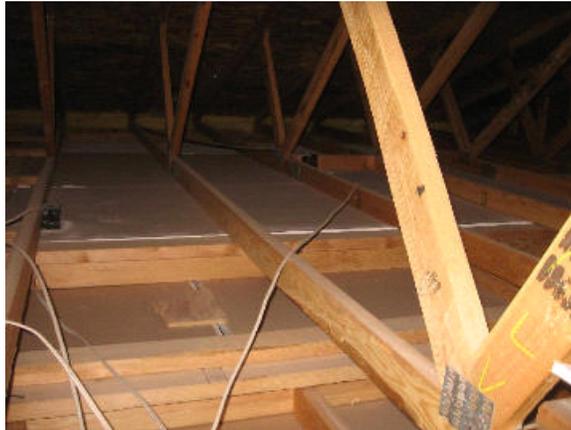
Insulation Noted:

No insulation is installed above the master bedroom and bathroom. This area is accessed from the downstairs hall ceiling hole.

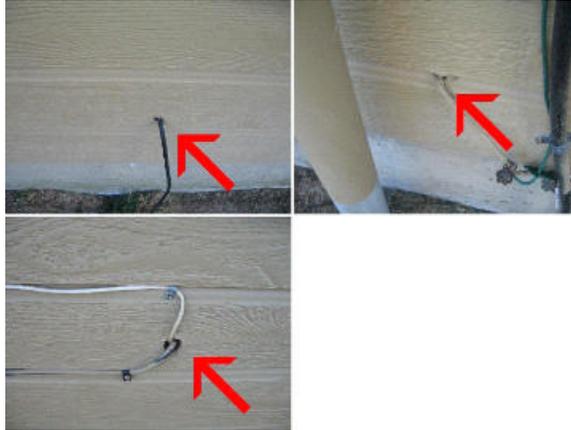
Siding Condition:

Satisfactory - The siding is in serviceable condition.
Caulk where lines run into siding on west side of home.

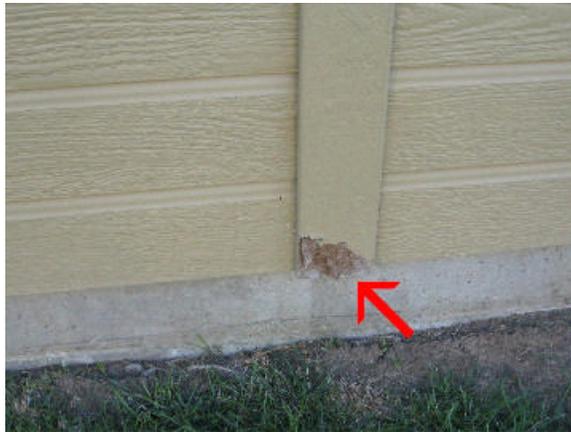
Trim Condition:

Satisfactory - The trim is intact and satisfactory.
Minor damage noted on trim, west side of home.

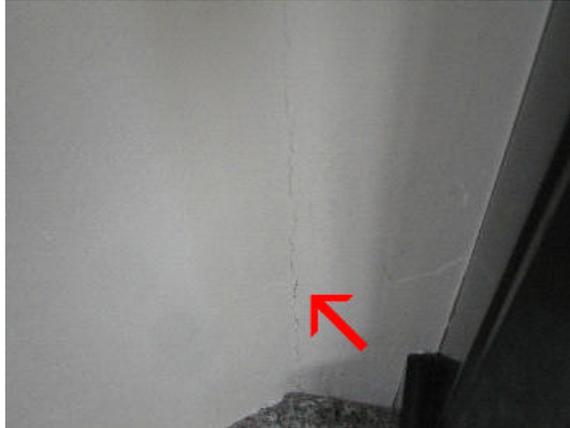
Wall Covering Material:

sheetrock. Appears Serviceable. Minor cracks in the walls, unless noted in the room-by-room descriptions, are considered normal shrinkage or settling. Next to fireplace.

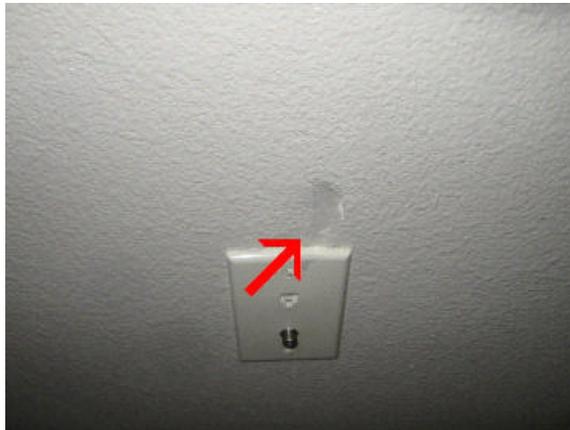
Other

Damage to wall in the front den.

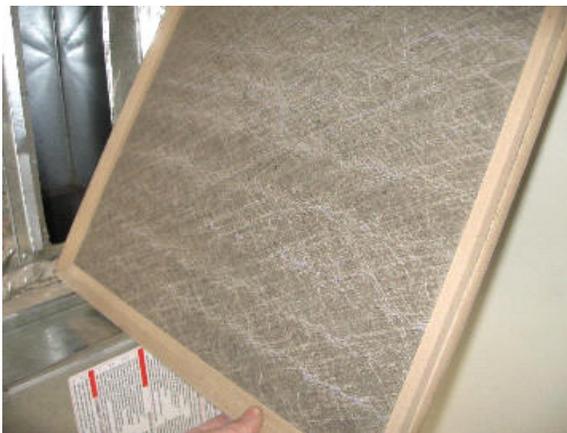
Filter Condition:

Attention Needed - The filter is in need of cleaning or replacement. Replacing or cleaning filters every 30 to 45 days is recommended.

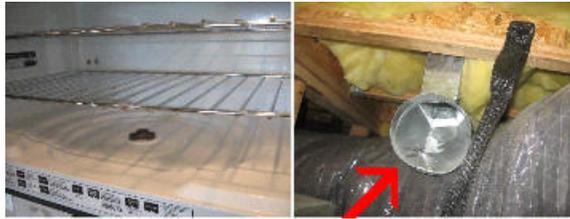
Microwave Oven:

Built-in - There is a built-in microwave oven. The unit was tested by heating a cup of water. The unit functioned as intended. *Vent for microwave oven discharges and ends in the crawl space. This should vent to exterior of home. No dish plate could be found.*

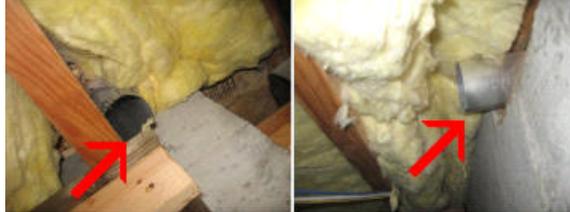
Dryer Ventilation:

Vent line is not connected in crawl space. Line goes into crawl and has the discharge end installed but no line installed.

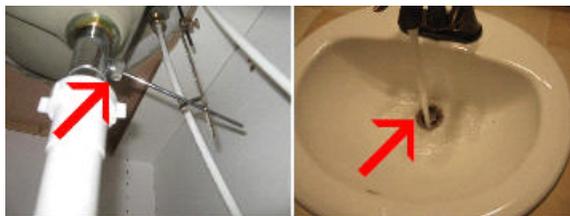
Basin and Drain Fixture:

Water leak noted on right sink at drain stopper connection. Right sink stopper did not stay down when tested.

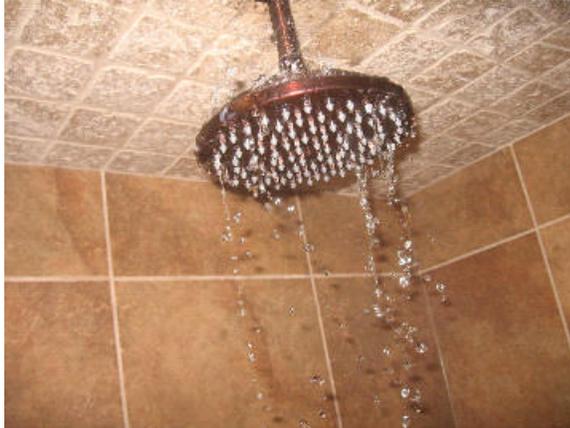
Shower/Shower Head and Mixing Valves:

Upper shower head does not function properly. Water runs out of top and not nozzles.

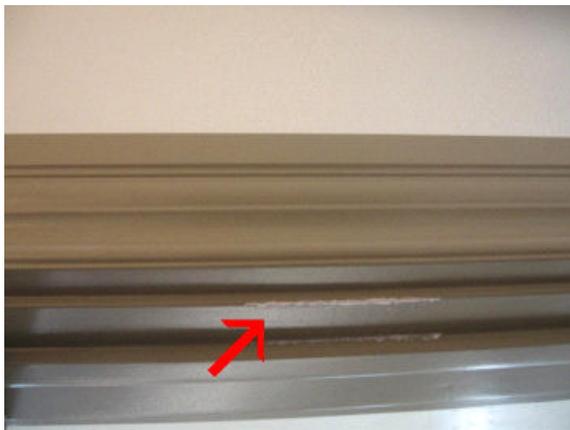
Entry Door:

Satisfactory - The entry door to the bathroom is as I expected, and it is functional.
Finish paint scratched off above door.

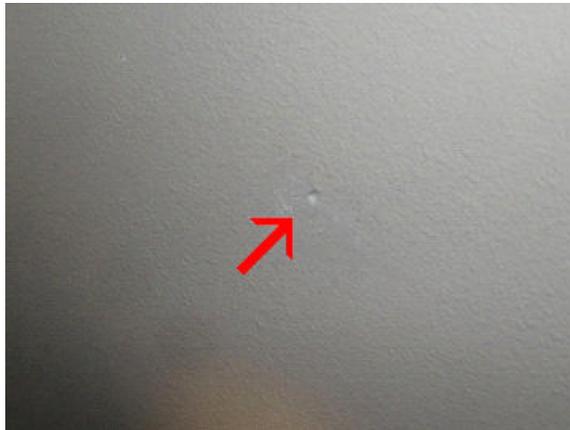
Toilet Condition

Satisfactory - The toilet in the master bathroom appears to be functional.

No toilet paper holder is noted and damage from one being installed.

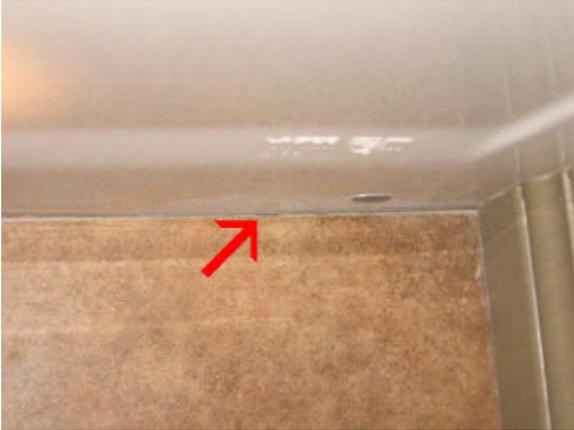
Caulking/Water Contact Areas:

Caulking is needed at tub base.

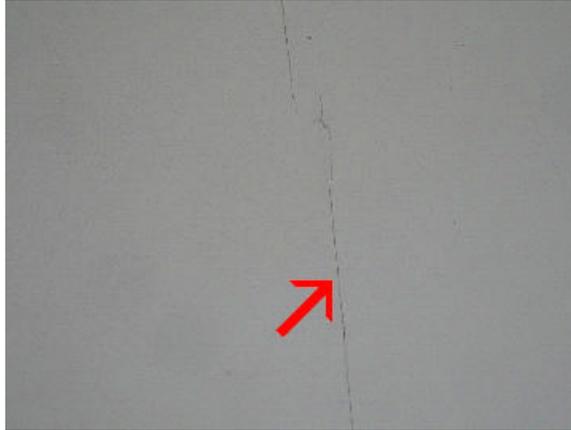
Garage Walls Condition:

Cracks noted on garage ceiling.

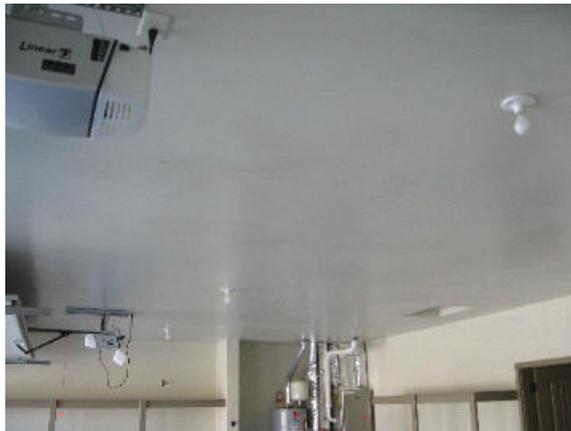
Lighting

Lights in garage did not work at the time of inspection. Likely bulbs are burnt out.
